# Merrickville Drinking Water System

## Annual Water Report

Prepared For: Village of Merrickville-Wolford

Reporting Period of January 1<sup>st</sup> – December 31<sup>st</sup> 2022

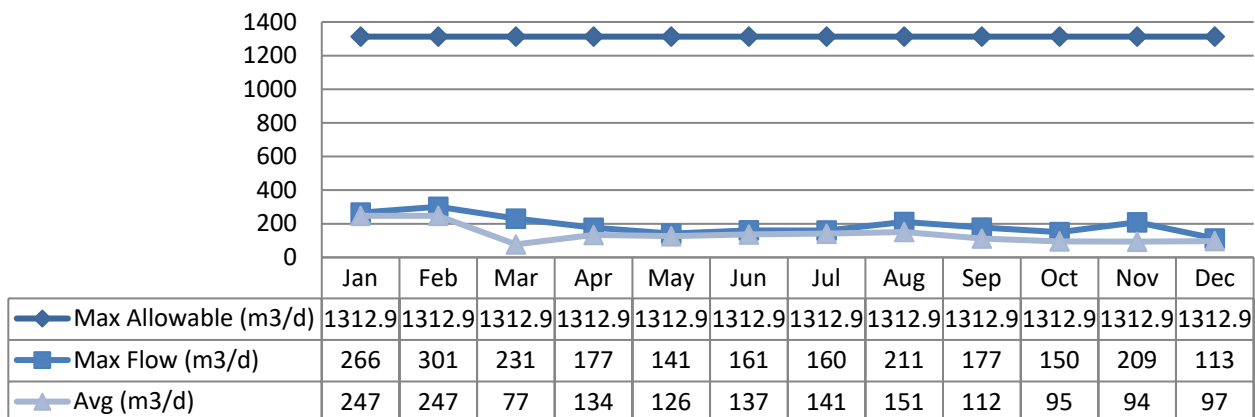
#### Well # 1 Total Monthly Flows (m3/d)

Max Allowable PTTW

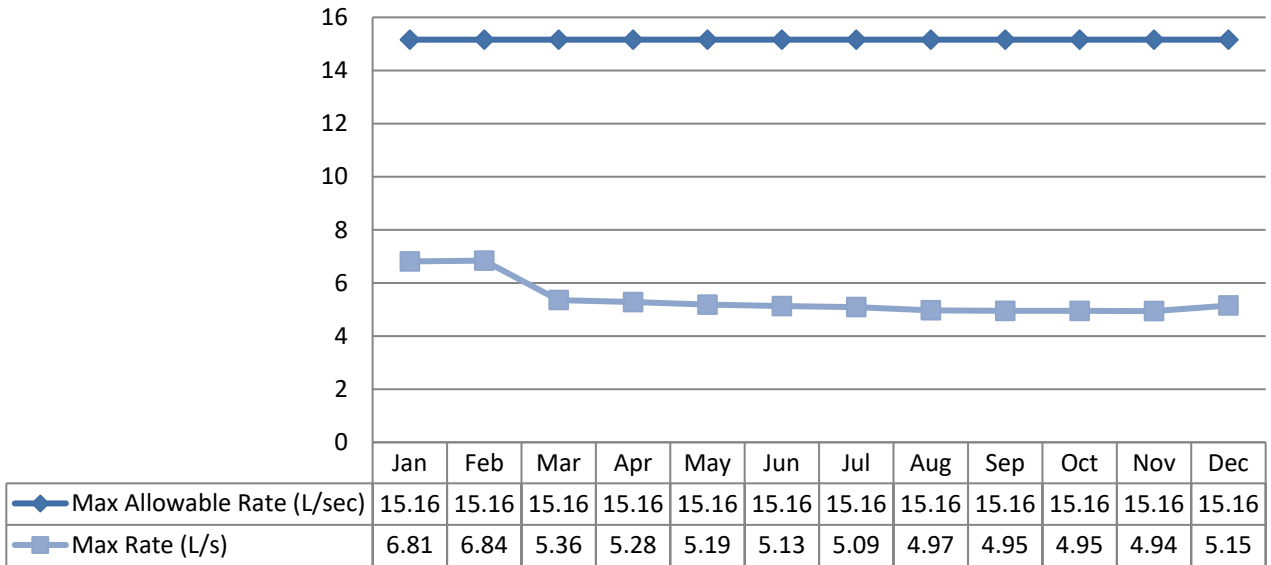
Well #1 Monthly Rated Flows (L/s)

Max allowable rate - PTTW

The pump for Well #1 is rated for 7.9 L/s

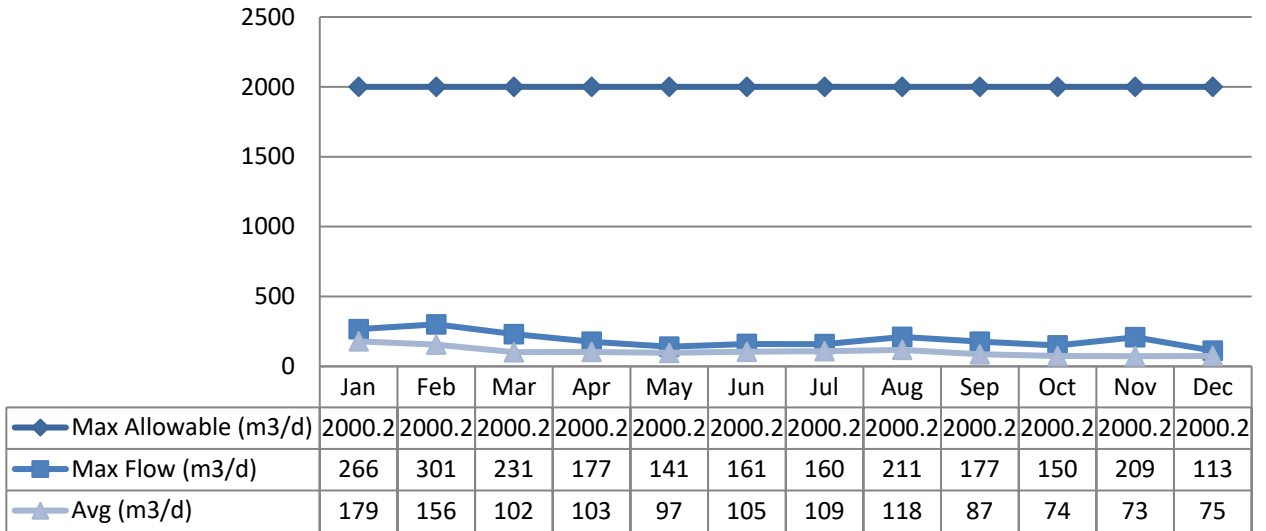
Well # 2 Total Monthly Flows (m3/d)

Max Allowable PTTW

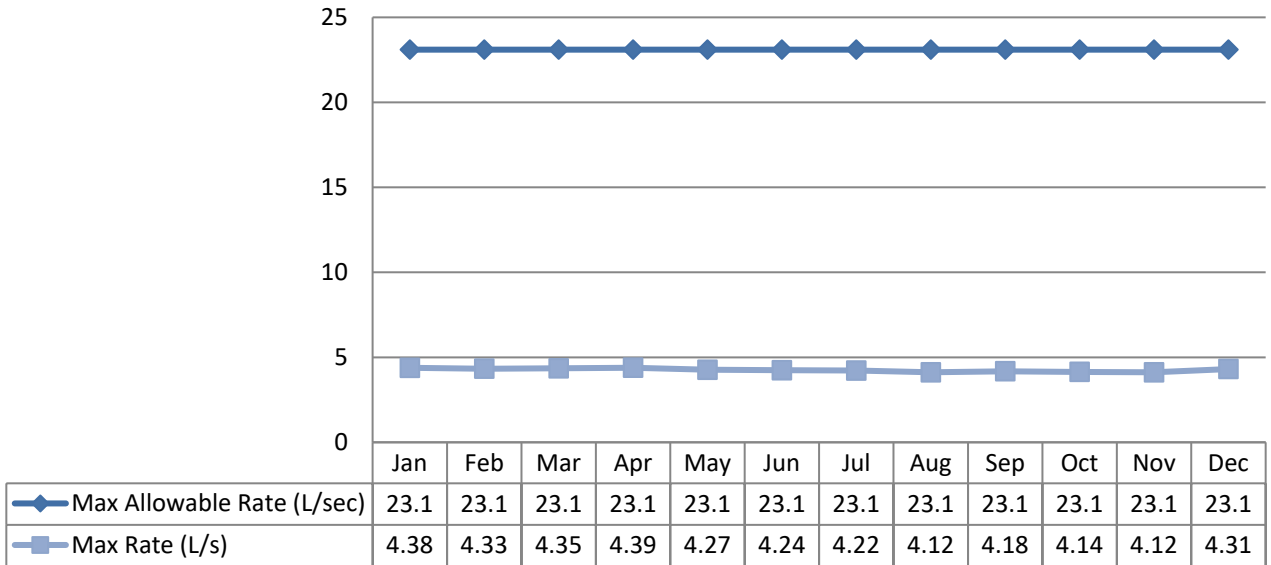
Well #2 Monthly Rated Flows (L/s)

Max allowable rate - PTTW

The pump for Well #2 is rated for 4.7 L/s

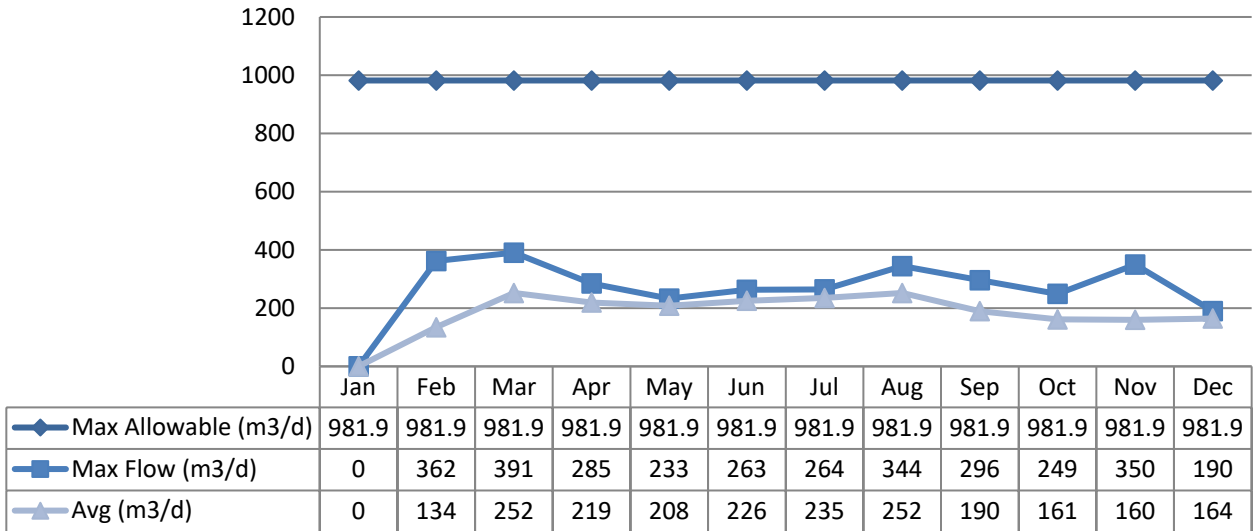
Well #4 Total Monthly Flows (m3/d)

Max Allowable PTTW

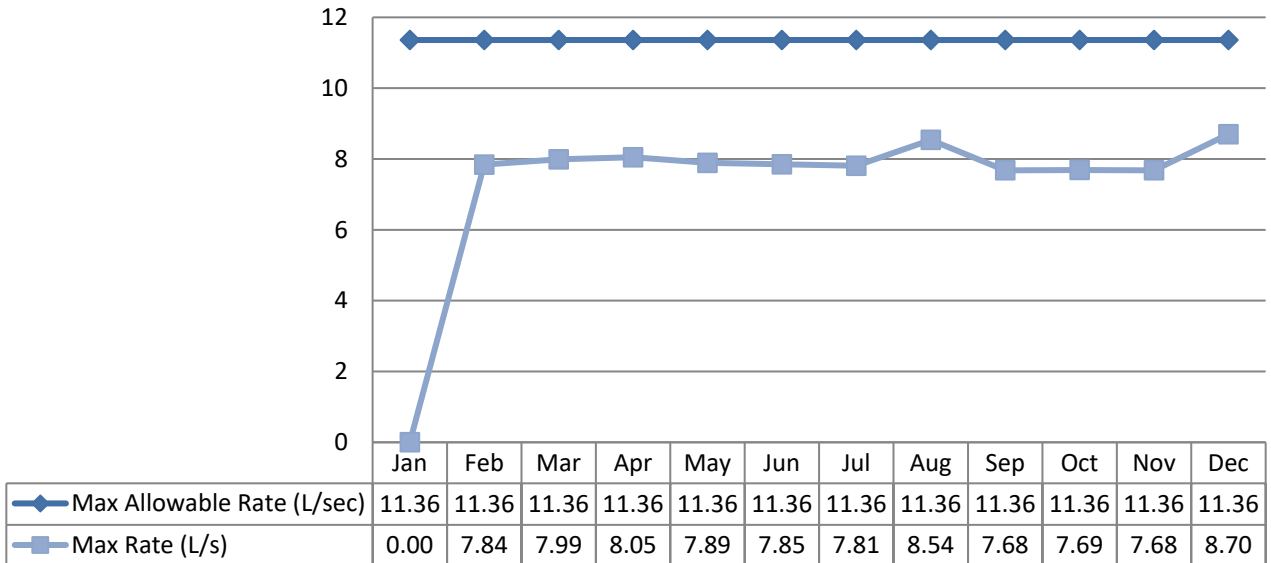
Well #4 Monthly Rated Flows (L/s)

Max allowable rate - PTTW

The pump for Well #4 is rated for 9.2 L/s

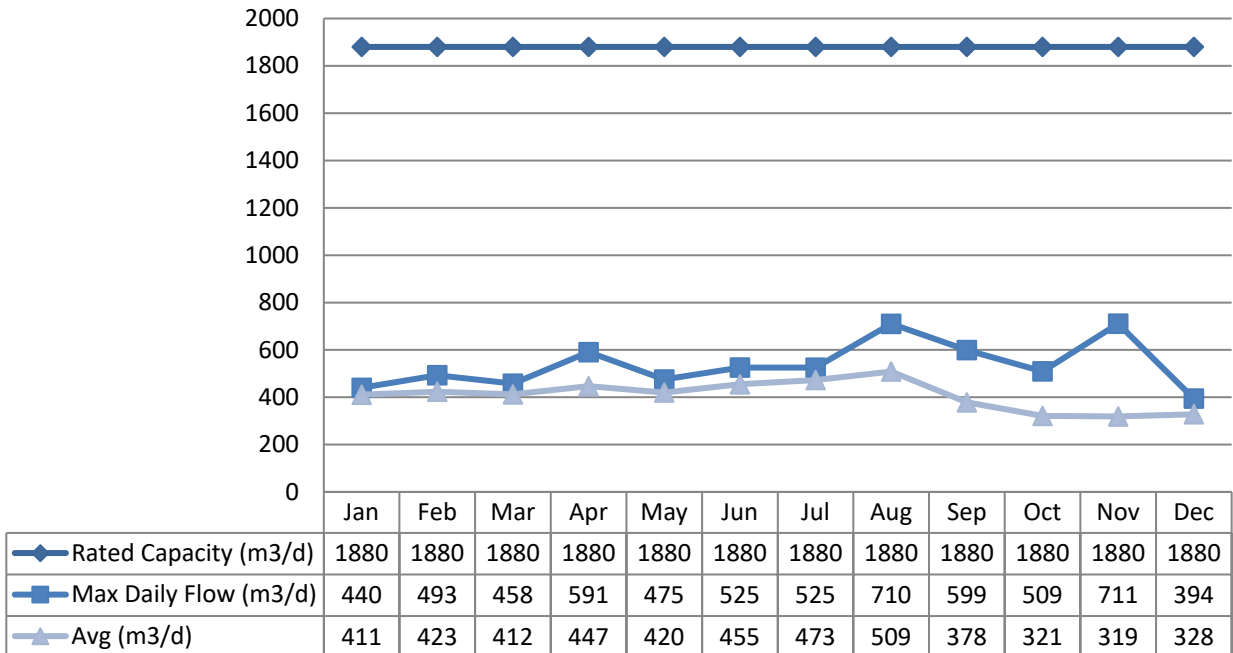
Monthly Rated Flows

The Treated Water flows are regulated under the Municipal Licence.

Rated Capacity - MDWL

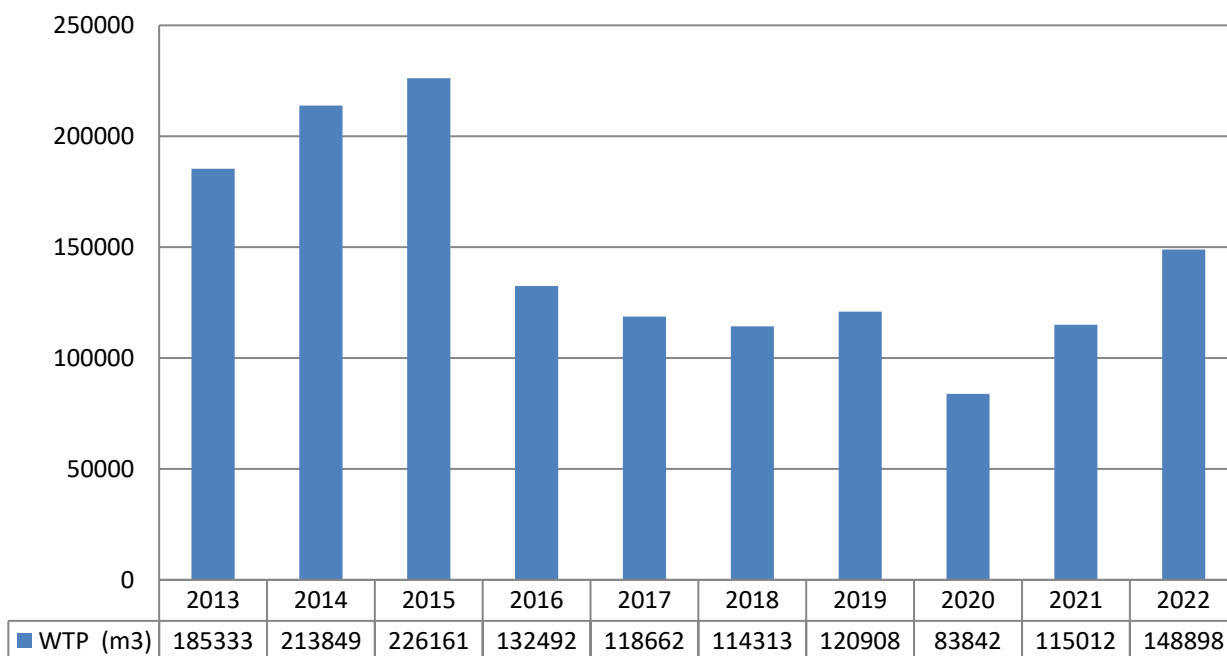
Annual Total Flow Comparison

Total Annual m<sup>3</sup>
